FABRICATION AND ENDURANCE OF AIR-COOLED STRUT-SUPPORTED TURBINE BLADES WITH STRUTS

CAST OF X-40 ALLOY

By Eugene F. Schum, Francis S. Stepka, and Robert E. Oldrieve

April 11, 1956 Declassified April 15, 1958

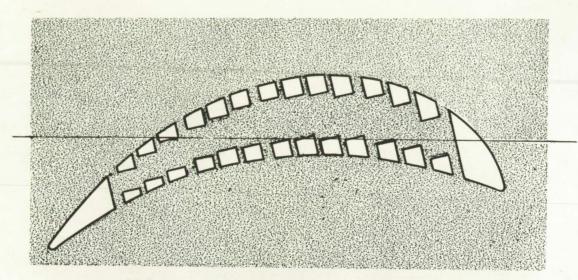
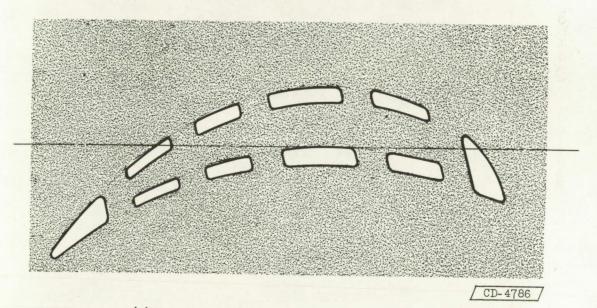
The first integral strut-base castings (which were not used for the blades reported herein) had the 0.020- and 0.040-inch secondary and primary fins, respectively, extending into and through the blade base. Because of the resulting small rectangular passages and the thin fins (both primary and secondary) at the base (fig. 4(a)), some shifting of the passage cores and shrinkage cracks in the fillet in the primary fins at the blade root occurred. Changes in the original dies were then made to remedy these casting difficulties. To provide larger passages the thin secondary fins were terminated 3/16 inch above the base platform and the thickness of the primary fins as they entered the base was increased to' 0.100 inch (figs. 1 and 4(b)). The increase in primary-fin thickness was to compensate for the loss of the shear area previously provided by the secondary fins. Shrinkage cracks in the fillet were eliminated by the increased primary-fin thickness and by increasing the radius of the fillet in these fins at the root from 1/16 to 1/8 inch (fig. 1). The acceptability of castings was determined by inspections with X-ray.

(a) Primary and secondary fins extending into base.

(b) Only primary fins extending into base.

Figure 4. - Comparison of blade cross sections at base (1/16 in. below platform) before and after modification required to eliminate casting difficulty.

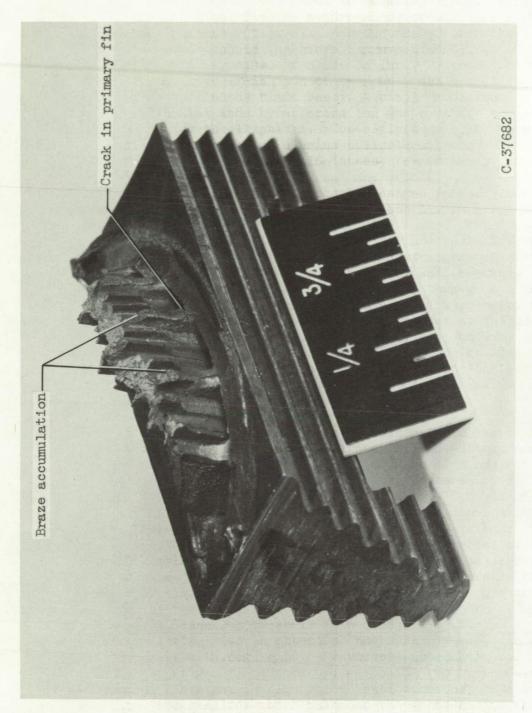
Endurance results. - Nominal blade root stress of 35,000 psi (blades 1 to 9): The life of the nine blades operated at the 35,000-psi root stress level ranged from minutes to a few hours. The lives of the individual blades are tabulated in table II. The blades generally failed in the root region of the strut, as shown in figure 6 (blade 5), which was typical of the failures.

fins of the strut, there was a tendency for the blade to fail through the area with the accumulated braze. The proximity of the braze accumulation to the location of strut failure is shown in figure 6 (blade 5). Failures of this type were not observed on the blades that were brazed with braze compound II.

Figure 6. - Typical blade failure (blade 5).

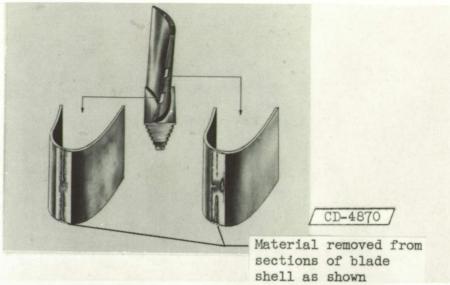
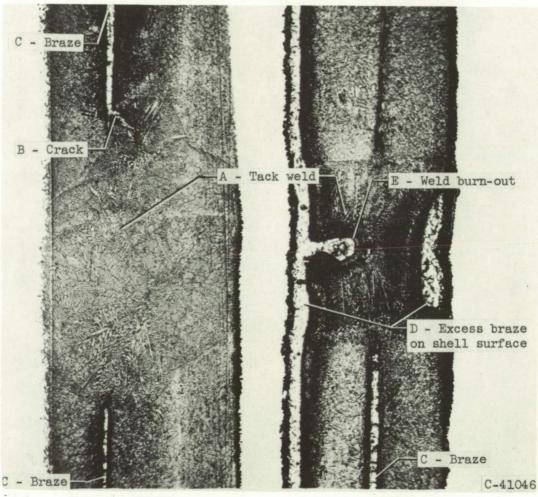
As mentioned earlier, tack-welding of the shell was used in the fabrication of some of the blades. Failure patterns observed on several blades indicated that tack-welding was one of the causes for shell failures. Photomicrographs of two tack-welded regions of the leading edge of a typical blade shell are shown in figure 7. Shown are sections through the leading edge of the shell halves as viewed upstream of the turbine blade. The region surrounding point A in figure 7(a) is the tack weld,

B is a slight crack in the shell material, and C is the braze that bonds the shell halves. Figure 7(b) illustrates another tack weld, observed on the same blade. The letter designations are the same as for figure 7(a). An excess of braze that flowed over a portion of the outer shell surface is designated D. The pockets or weld burn-outs (E) are filled by braze. The resulting stress concentration at this point could cause blade failure.

(a) Lower tack weld.

(b) Upper tack weld.

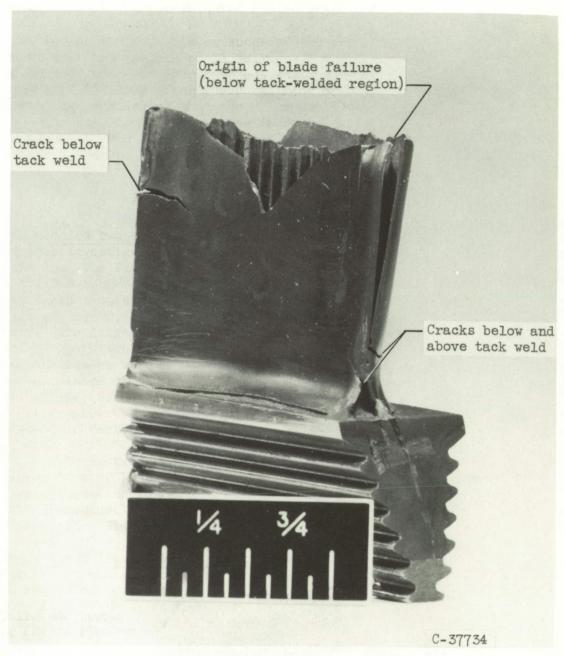
Two blades containing elliptical coolant passages in the blade base failed in 2 and 3 hours, a life comparable with that before strut modifications. The 3-hour blade (blade 18) failed 1.5 inches from the blade platform (3/8 span) as shown in figure 9. This failure was different from the earlier failures in that the blade failed at a greater distance from the blade base and severe cracking of the shell was observed. The cracks shown on the leading edge progressed through a tack-welded region. The failure at the 1.5-inch span appeared to have originated below a tack-welded region. Examination of the strut showed that it failed in fatigue in the strut leading edge. This fatigue may have been due to a shell crack progressing to the strut and causing a fatigue failure. This type of blade failure provides additional evidence that the tack-welding of the shell may have a detrimental effect on blade life. Failure of the 2-hour blade occurred 3/8 inch from the blade base.

Figure 9. - Failure of blade 18 (modification 3) after 3 hours of operation.

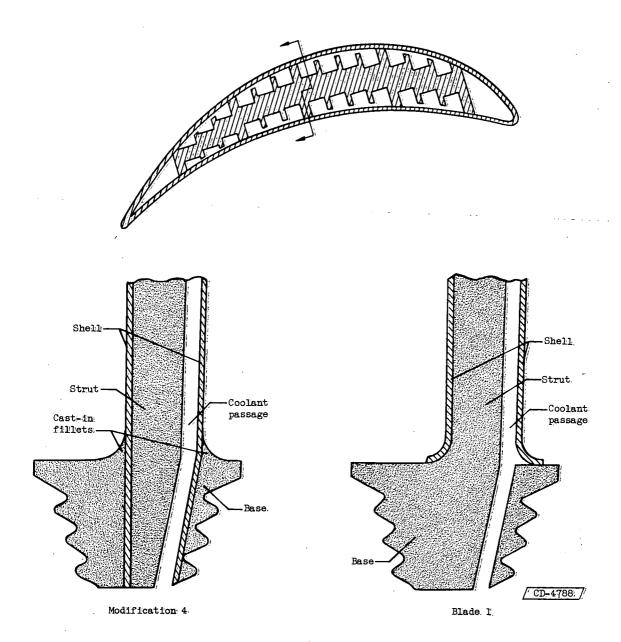
Modification 4: Extension of shell into blade base (blades 19 to 21). - Modification 4 consisted in extending the shell directly into the base as shown on the left in figure 10. Previously, the shell did not extend into the base but was flared and brazed to the top of the blade platform as shown on the right in figure 10. Extending the shell into the base eliminated the need for the closing of the holes in the fillet region of the blade base and shell at the leading and trailing edges. As mentioned earlier, this welding may have been a cause for shell failures. In addition, with modification 4 the shell in the fillet region is in the direction of the centrifugal loading on the blade, which may provide more rigidity.

Figure 10. - Comparison of modification 4 (extension of shell into base) with blade 1.

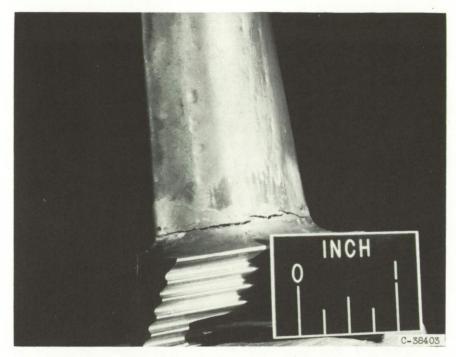
The life of the three blades tested (blades 19, 20, and 21) with this modification ranged from 12 to 53 hours. These results indicate that the modification increased blade lives over those previously tested. Tests on blade 19 were concluded when a shell failure (shown in fig. 11(a)) occurred after 12 hours. The failure occurred at the top of the cast fillet. A microscopic examination of the blade, which was sectioned, showed that the brazed joint between the shell and the strut along the suction surface was poor. The results of this examination also showed that the shell necked down under the tensile load. The second blade (blade 20) failed completely at the top of the fillet after 24 hours of operation (fig. 11(b)). Tests on the third blade (blade 21) were terminated after the blade completed 53 hours of operation. A very small crack on the suction surface and at the top of the fillet, however, was observed in this blade. The notch effect at the junction of the shell and the top of the fillet may have been the cause of the failure of the shell.

(a) Blade 19, shell failure after 12 hours of operation.

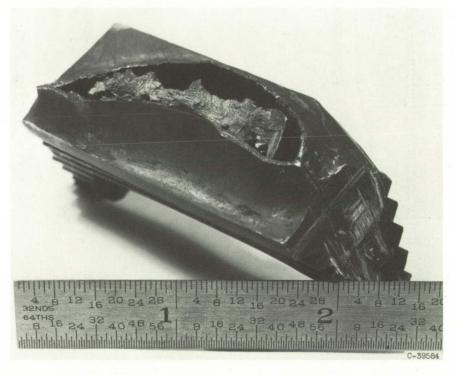
(b) Blade 20, failure after 24 hours.

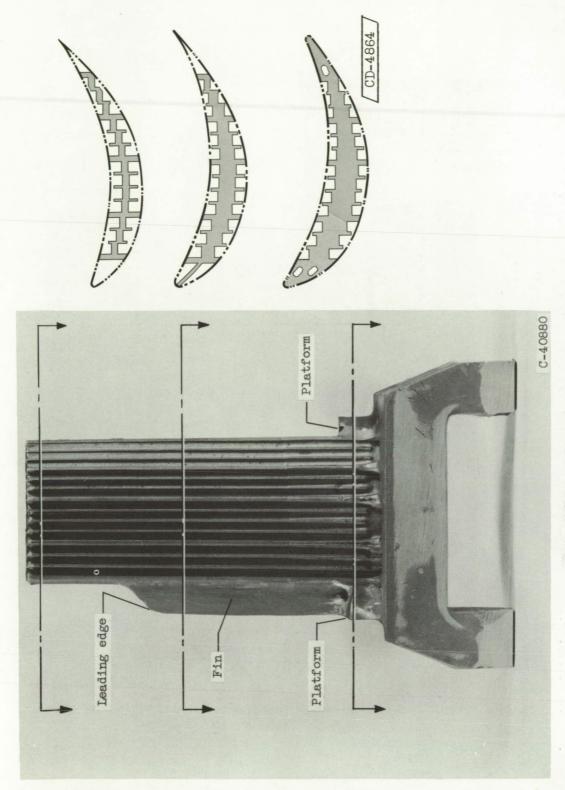
Modification 5: Platform at leading and trailing edges and supporting fin at leading edge (blades 22 and 23). - Modification 5 was intended to reduce shell failures by the addition of a supporting platform at the base of the leading- and trailing-edge regions and by a supporting fin extending from the strut to the leading edge of the shell (fig. 12). platform had a height of 3/8 inch and was cast integrally with the strut and blade base. Passages were provided in the platforms for coolant. The blade shell, which was flared in the usual manner in the fillet region, was brazed to the sides of the platforms. This method of fabrication eliminated welding in these regions. The fin in the leading edge, which was brazed to the shell, provided added support to the shell. For the two blades tested, the shells were of one-piece construction, so formed that only the trailing edge needed heliarc welding. The two blades successfully completed 50 and 66 hours of engine operation, after which testing was terminated. During the testing of the blades a 1/2-inch spanwise crack developed at the trailing edge of the shell at the blade tip. crack was rewelded and operation continued. The test results indicate that the use of the support platform, the supporting fin, and the onepiece shell with a welded trailing edge (no welding at the leading edge) had a significant effect on increasing blade life. It appears that a further improvement could be made if a blade shell could be fabricated without welding of either the leading or the trailing edge.

Figure 12. - Modification 5: Platform at strut leading and trailing edges and supporting fin.

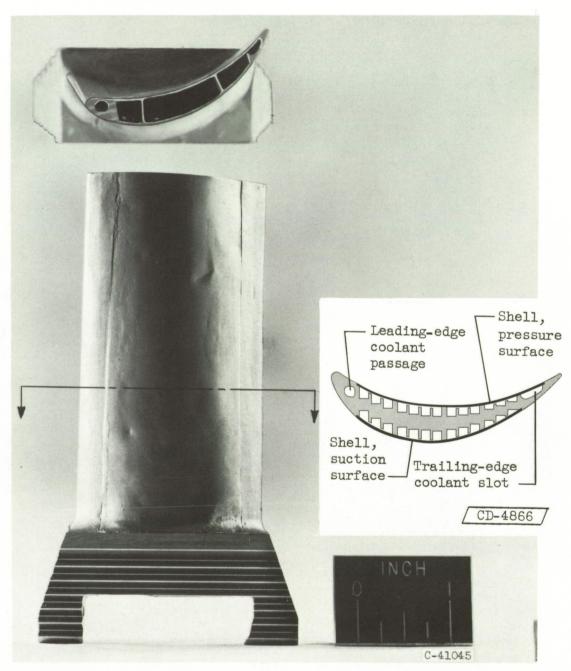
the weld cracks was attempted by casting the leading and trailing edges integrally with the strut. A photograph of a blade having this modification is shown in figure 13 along with a sketch illustrating the general assembly of the shell halves to the strut. The elliptically shaped leading-edge coolant passage (fig. 13) was obtained by the use of a shaped core of alumina silicate in the wax pattern. The rectangular trailing-edge coolant passage was obtained by hand removal of the wax from the wax pattern. The shell half that served as the pressure surface of the blade also served to enclose the trailing-edge cooling passage. For cooled-blade operation this modification would result in higher leading- and trailing-edge blade temperatures as compared with the preceding blades.

Figure 13. - Modification 6: Cast leading and trailing blade edges.

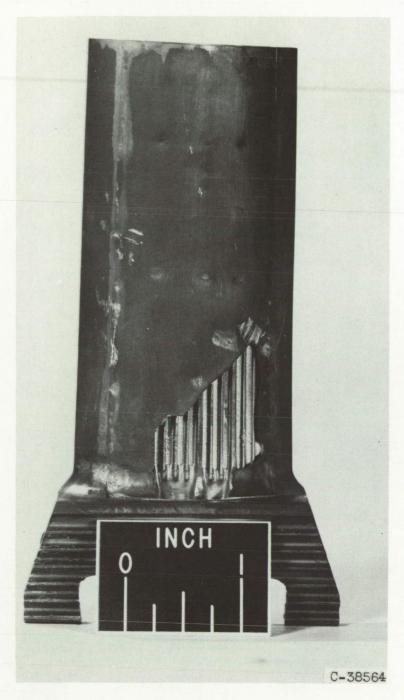
The life of the three blades of this configuration (blades 24, 25, and 26) ranged from 18 to 54 hours. A shell failure in blade 24 after 18 hours (fig. 14) due to poor braze of the shell to the strut, terminated the tests of the blade. The two other blades completed 54 hours of operation, which was considered adequate to indicate the merits of this configuration. One of the two blades (blade 25) had a slight shell crack in the fillet region on the suction surface. This crack was also a result of a poor braze. Because the failures of the shells of blades 24 and 25 were due to poor brazing, the shell failures should not be considered in the evaluation of this modification. The lives obtained with the blades of this modification are attributed to the elimination of the welding of the shells, as well as possible reduction in vibratory stresses due to the sturdier leading- and trailing-edge sections of the blade.

Figure 14. - Shell failure of blade 24 (modification 6) after 18 hours of operation.
